S-190 Turkey Branch Road House Near Westover Site

Survey No. S-190

Maryland Historical Trust State Historic Sites Inventory Form

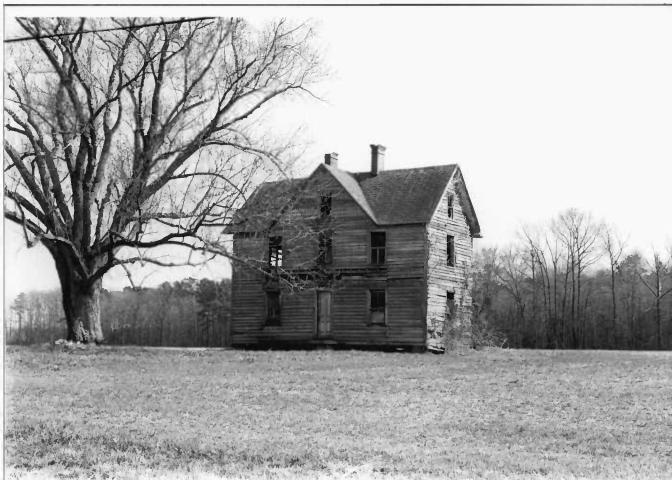
Turkey Branch Road Farm S-190
Westover vicinity, Somerset Co.,Md.
North Elevation
3/84, Paul Touart, Photographer
Neg./Md. Historical Trust
